# Performance Evaluation of the Adapazari City Hall Building Retrofitted Prior to the August 17, 1999 East Marmara Earthquake ( $M_w$ 7.4)

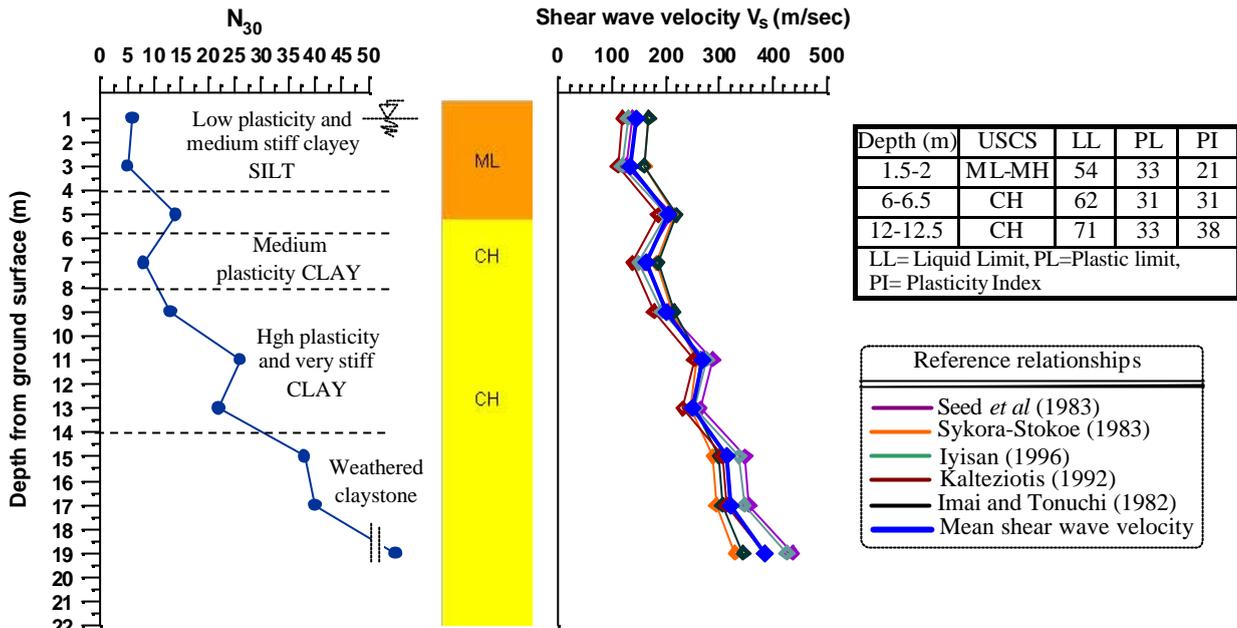
On the August 17, 1999 event the foundation displacements in the forms of settlement, tilting and lateral movement were broadly observed in the Tıgçılar, Cumhuriyet, Orta and Kurtulus districts of Adapazari [8] [9]. But collapse and heavy damage (20-40 % of total number of buildings in district) occurred in the İstiklal and Karaosman, Semerciler, Pabuççular, Yenicami and Yenidogan districts [8] in which no or limited foundation displacements due to bearing capacity failure and liquefaction phenomena was reported. The Adapazari City Hall also locates in Semerciler district and the soil profile (from data provided by Köksal referring DRM-MERM research project [13], [14]) down to 20 m depth in its vicinity is given in Fig 2. Thick CLAY layers with medium to high plasticity prevented soil displacements and liquefaction phenomena. About 14 m depth the sequence grades into weathered claystone. At 10 m depth the average shear wave velocity corresponding to N<sub>60</sub> count 26 is predicted as V<sub>s</sub> 270±20 m/sec from mentioned relationships (Fig. 2). The described soil profile of the Adapazari City Hall site signifies the class B2 according to site soil classification system in [15]. This site class stands for stiff cohesive soils with medium depth (< 60 m) for V<sub>s</sub>>150 m/sec and NEHRP D class as well. The soil condition B2 of the Adapazari City Hall ~7.5 km away from SKR station in which the PGA value was recorded as 407 gal (EW) implies not amplified PGA values with respect to the site-dependent acceleration relationships. This fact was confirmed in [8] as well.

Fig. 2 Soil profile and predicted shear wave velocities from  $N_{30}$  count in the vicinity of Adapazari City Hall

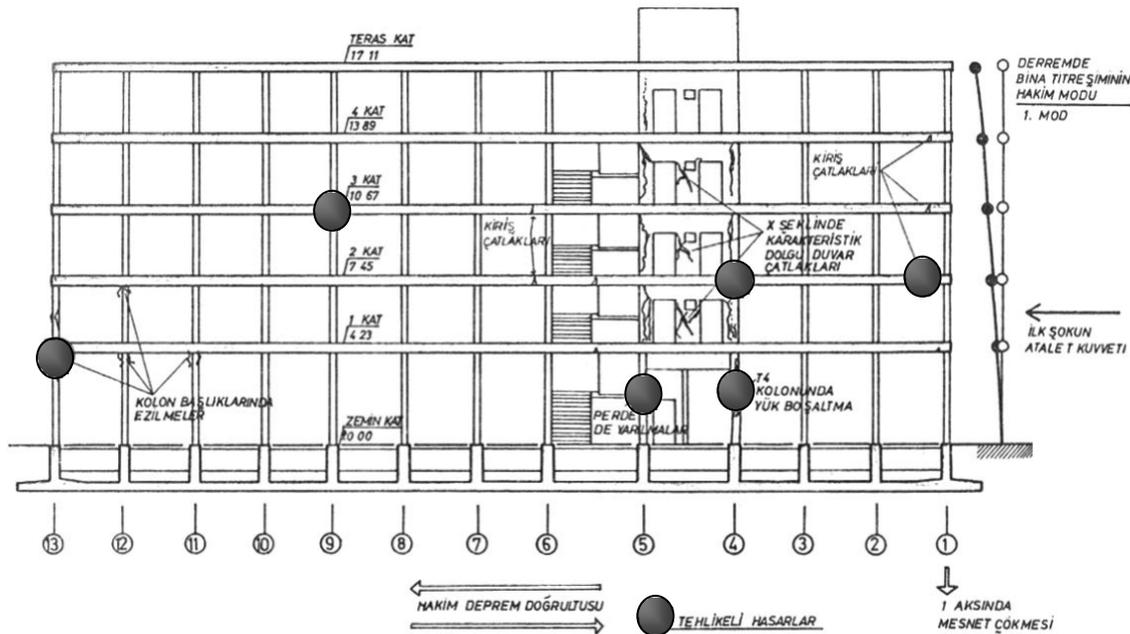
During July 22, 1967 Akyazi earthquake and subsequent July 30, 1967 aftershock, the Adapazari City Hall suffered heavy damage. No concept of ductile detailing knowledge were available in the early 1960s (Fig. 3, 4). A typical damage section in the longitudinal direction is seen in Fig. 3. Excessive deformations concentrated in columns of the lower stories occurred in the form of unloading, spalling, crushing, compression failure and reinforcement buckling. In the lightweight brick infill walls of the stair and elevator shaft heavy shear cracks were observed. Beams of joist slab floors sustained damage as well.

Fig 3. Damage pattern of the Adapazari City Hall Building after the 1967 Akyazi earthquake [4]

The authors of this paper undertook the retrofitting responsibility of the Adapazari City Hall contrary to some opinions that the *building should be demolished*. All retrofitting works including repair and strengthening were completed using conventional methods within 8 months. To increase seismic performance new transverse perimeter shear walls were constructed on the Grids 1 and 13 throughout the height of the building (Fig. 5). Transverse interior shear walls were added on the Grids 8, 9 and 10 and short longitudinal shear walls were placed to the four corners as well. 18 columns were included into the new added shear walls, other 17 columns were retrofitted by jacketing minimum 10 cm after removing cover. To improve the lateral rigidity of building the new rigid deep beams were constructed in the sizes of 30 by 90 to 51 by 90 cm in the ground and roof floors. At the other floors new beams of 52 by 40 cm were added to the system. The structural masonry walls of solid brick to ground floor were added to enhance seismic energy damping ratio. The foundation system was strengthened by enlargement. The roof covering was lightened by removing heavy gravel load with isolation aim.

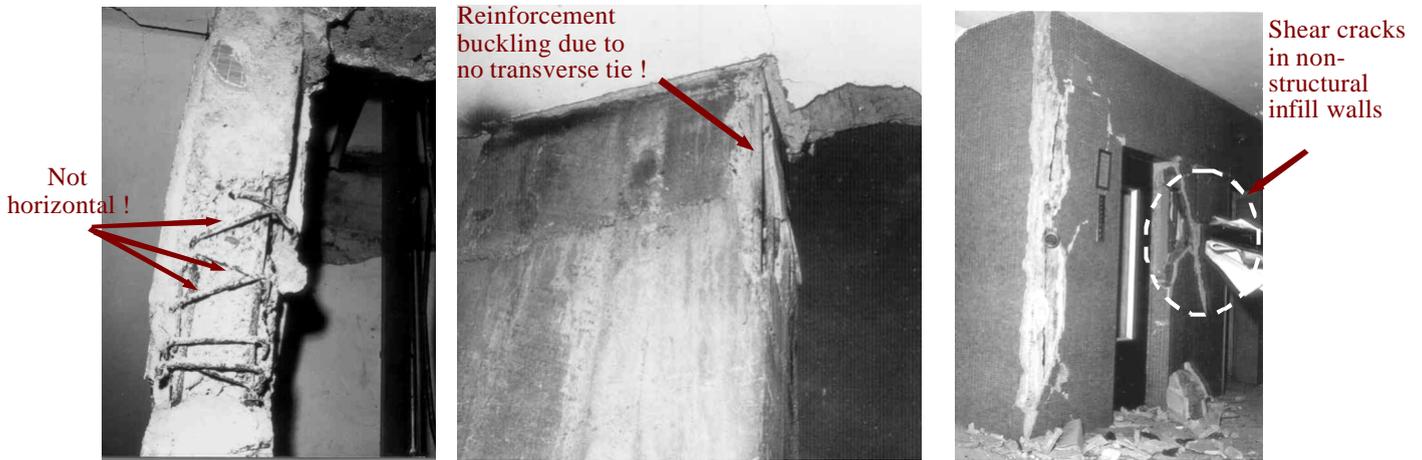
Fig.4 Typical examples to structural and non-structural heavy damage in the building after July 22, 1967 earthquake [4]

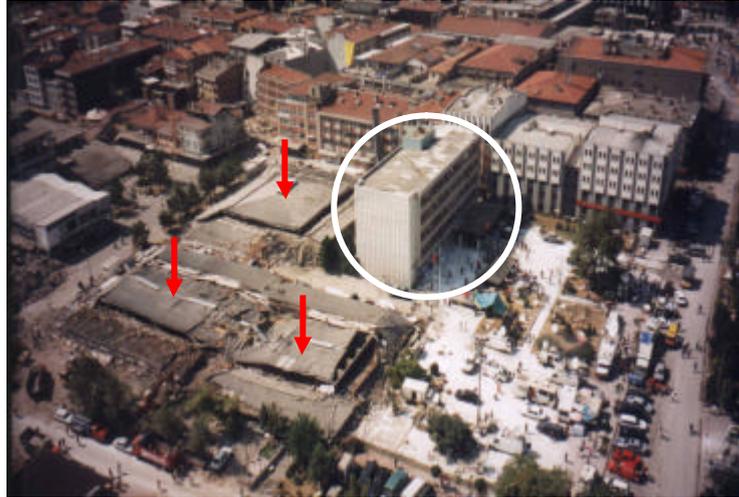
where r is correlation coefficient. The static offset was about 185 cm [10]. Structural damage was enormous at about central area in which the Adapazari City Hall also locates and the City Hall was one of a few buildings not suffered to structural damage [6], [7] (Fig. 6) and used as the crisis management headquarter to direct the earthquake relief efforts.

*Fig. 6 An aerial view of the Adapazari City Hall and the pancake-type collapses in its vicinity (after the 17 August 1999 earthquake)*

The significantly enhanced structural capacity and minimized torsional irregularities through removing eccentricity between mass and rigidity centres resulted in the remarkable performance without structural damage of Adapazari City Hall in 1999 earthquakes. According to seismic vulnerability assessment method [16], which is calibrated on the 2-6-storey 54 R/C buildings suffered to damage at various levels during the 17 Aug. and 12 Nov. 1999 earthquakes, the minimum value 0.33 of the Wall Indices ( $I_w$ ) in each direction (Table 2) is highly above the slight to no damage limit of 0.20 contrary to the almost zero value of original building prior to retrofitting.
