# AN UNDERGROUND SHOPPING CENTER FIRE AND AFTER-FIRE REPAIR PROJECT

by Ersin ARIOGLU , Koksal ANADOL and Ali CANDOĞAN

*In this article, a fire which took place in the largest underground shopping center of Istanbul (Turkey) and its after-fire repair and strengthening project prepared by the authors are reported.*

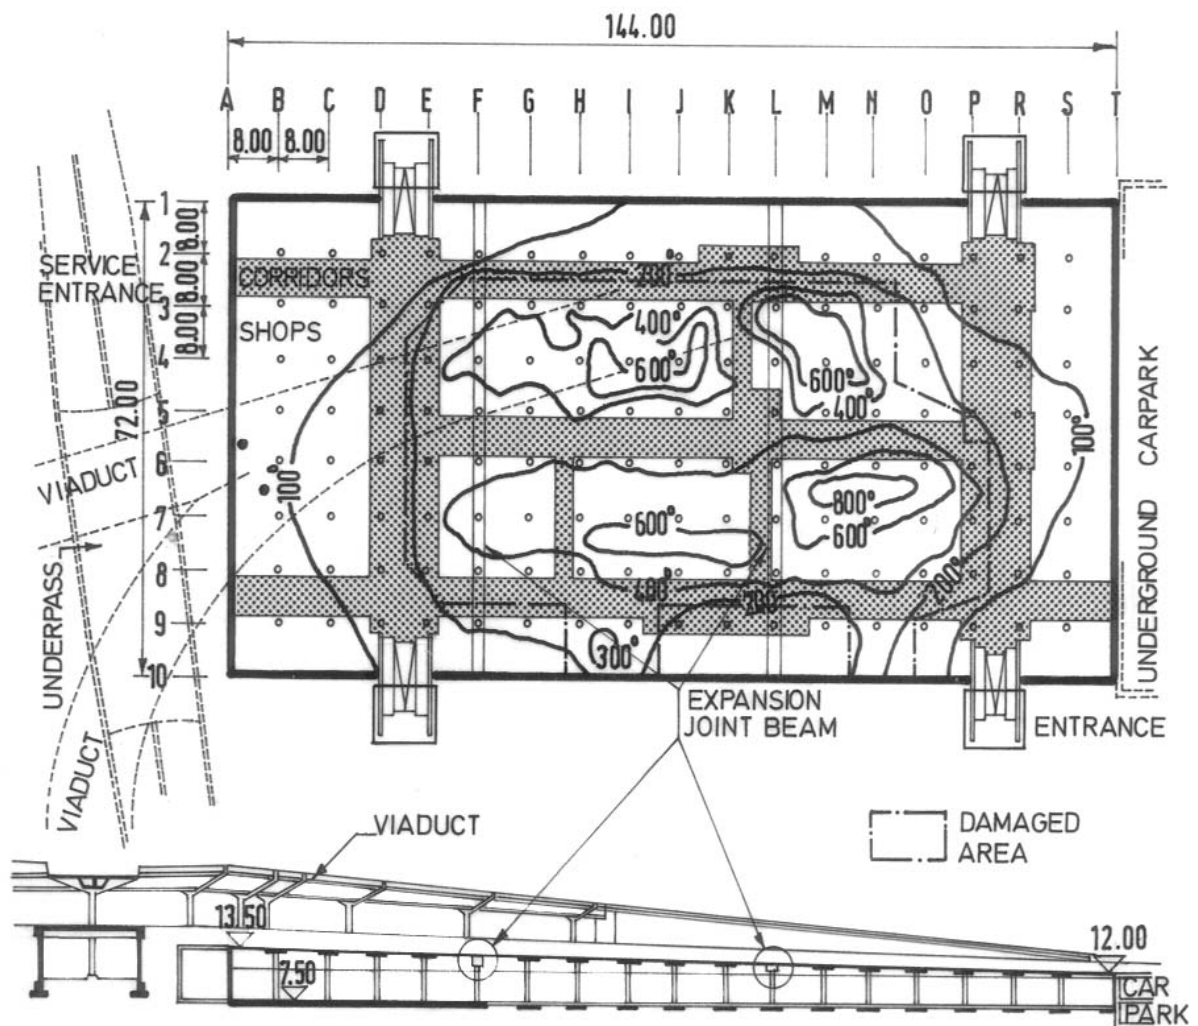
Fig. 1 -AKSARAY UNDERGROUND SHOPPING CENTER PLAN AND FIRE SPACE ISOTHERMS

In the Aksaray repair project, first, maximum fire space temperatures were estimated by inspecting the fire debris and the structure's condition. After these inspections and surveys, it was concluded that the minimum space temperature was 100°C while the maximum temperature reached 800°C at certain locations (Fig 1).

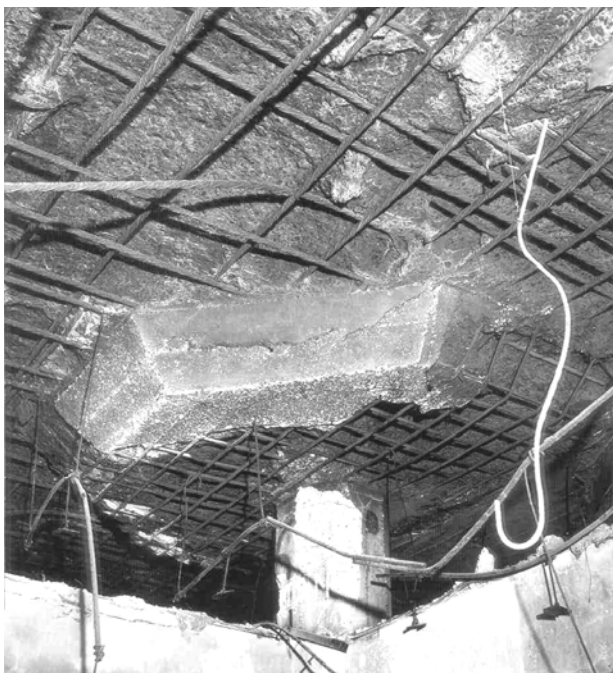
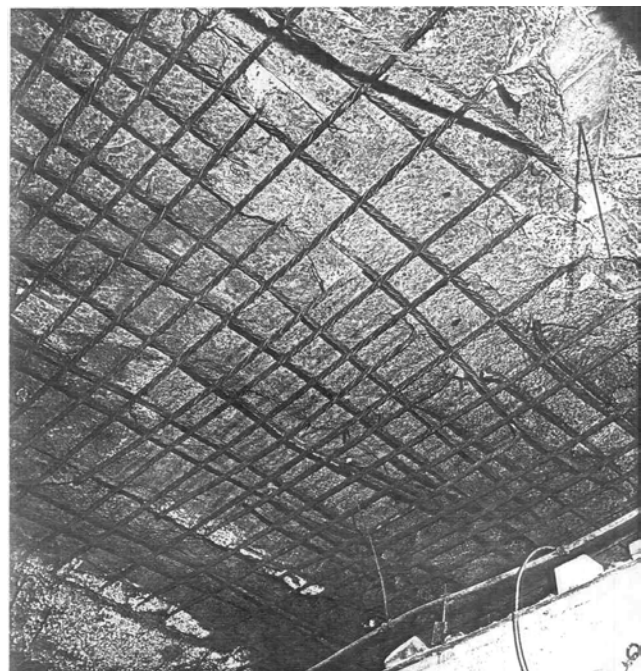
Fig. 2 -STRUCTURAL DAMAGE PHOTOS

- The structural and cosmetic damages of these regions were photographed (Fig.2).
- At several locations, concrete strengths were estimated using Schmidt Hammers and ultrasonic instruments. Furthermore, cores were drilled out and compression tested in the laboratories.

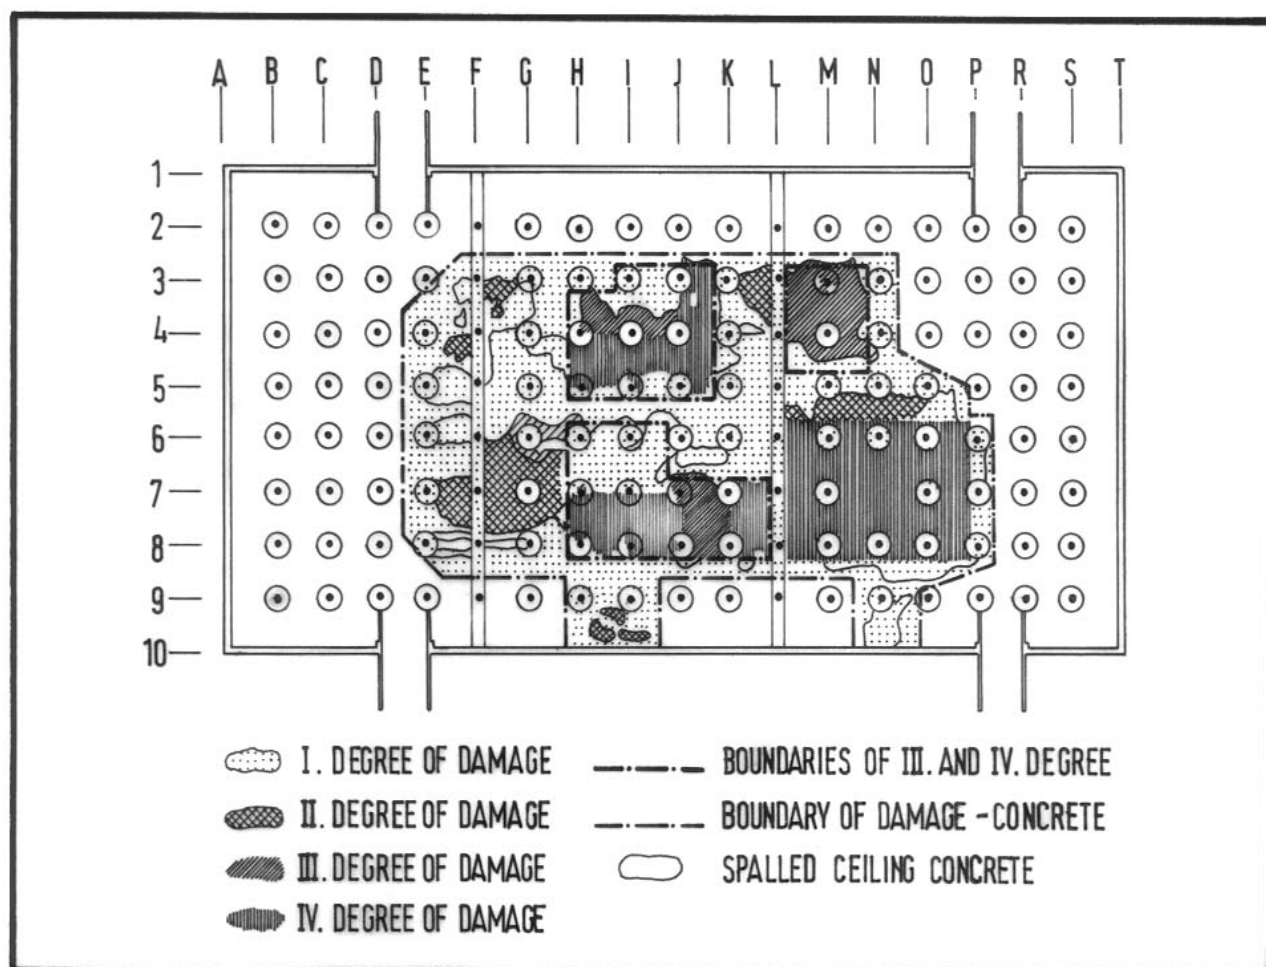
Fig. 4 - DEGREE OF DAMAGE CLASSIFICATION

- Based on these surveys, tests, and reports, the shopping center was damage classified (Fig.4) using the criteria given in Fig.3.

The most important fire damage occurred at the ceiling slabs. At the I and II.degree damaged regions cosmetic repairs (cleaning the rust of the reinforcement by wire brushes, cleaning the smoke and soot from the concrete surfaces by wire brushes-acid solutions-chisels, water cure, shotcreting, and perlite plastering) were sufficient.

In the III.degree damaged regions, first, the deformed and sagged reinforcement which had lost their characteristic material properties were cut out and St IIIa reinforcements were welded in their place. Then, cosmetic repair was applied.

In the IV.degree damaged regions, besides the repair measures used for the III.degree regions, structural strengthening was required. Thus, the IV.degree damaged modules were supported with a strengthening column at their centers. The construction principle of these columns is summarized in Fig.5. Load displacement measurements taken during the construction of the HI 67 column are given in Fig.6. In the repair project, 17 strengthening columns were used at the IV.degree damaged areas.
